# Service Bulletin

Applies To: 2006 RSX - Check the iN VIN status for eligibility

# Safety Recall: Brake Booster Loses Vacuum

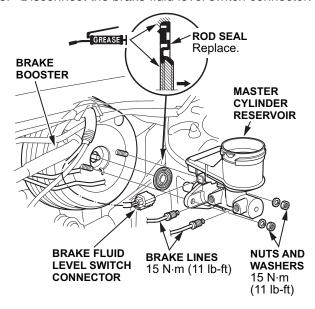
- 1. Remove the air cleaner.
- 2. Remove the brake fluid from the master cylinder reservoir with a syringe.
- 3. Disconnect the brake fluid level switch connector.

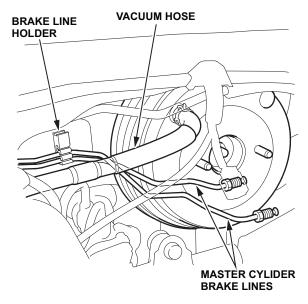
7. Disconnect the brake booster vacuum hose from the brake booster.

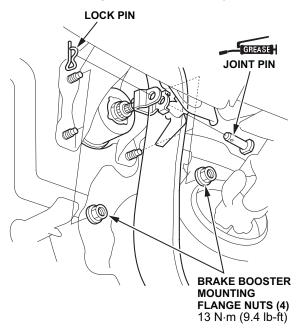
- 8. Remove the master cylinder brake lines from the brake line holder.
- 9. Remove the lock pin and the joint pin, then disconnect the yoke from the brake pedal.
